How to look after your witchert building

2.3

What is witchert?

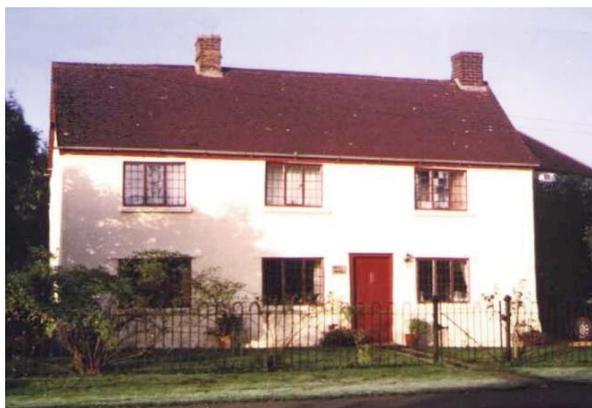
An early 19th century witchert house in Grendon Underwood, recently lime-rendered and lime washed after its pebble-dash had been removed.

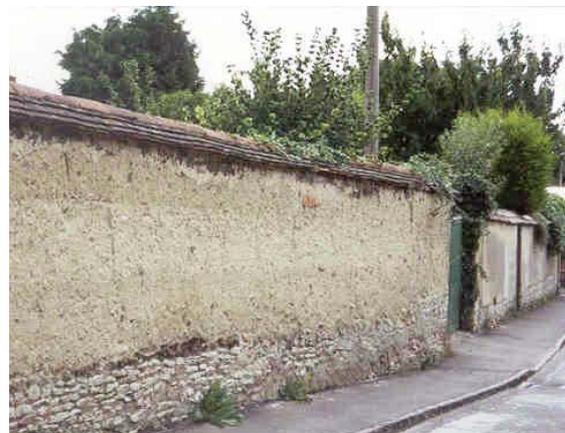
Witchert wall showing three berries above the grumplings. The coping is formed from plain and half round tiles.

The walls are constructed as follows. A plinth of rubble stones, known locally as 'grumplings' or 'grumblings', is constructed. This is essential to prevent rising damp and to allow penetrating rain to soak away freely. The taller the grumplings the better the protection from splash-back and surface water.

The well-prepared witchert is put onto the stone foundation in layers, known as berries, of about 0.45 m (18") or more along its length and left to dry before the next berry is added. The sides are trimmed with a sharp spade. The walls may then be rendered for decorative purposes, but garden walls are usually left without a coating and do very well.

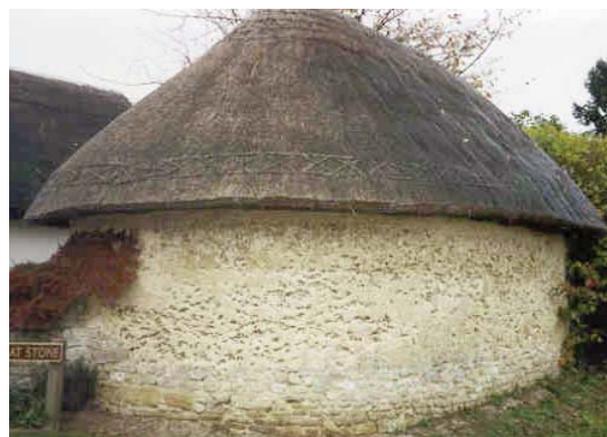
Small thatched witchert stable, the walls are pockmarked by masonry bees, but remain sound and dry under the overhanging thatch and above the unaltered stone plinth

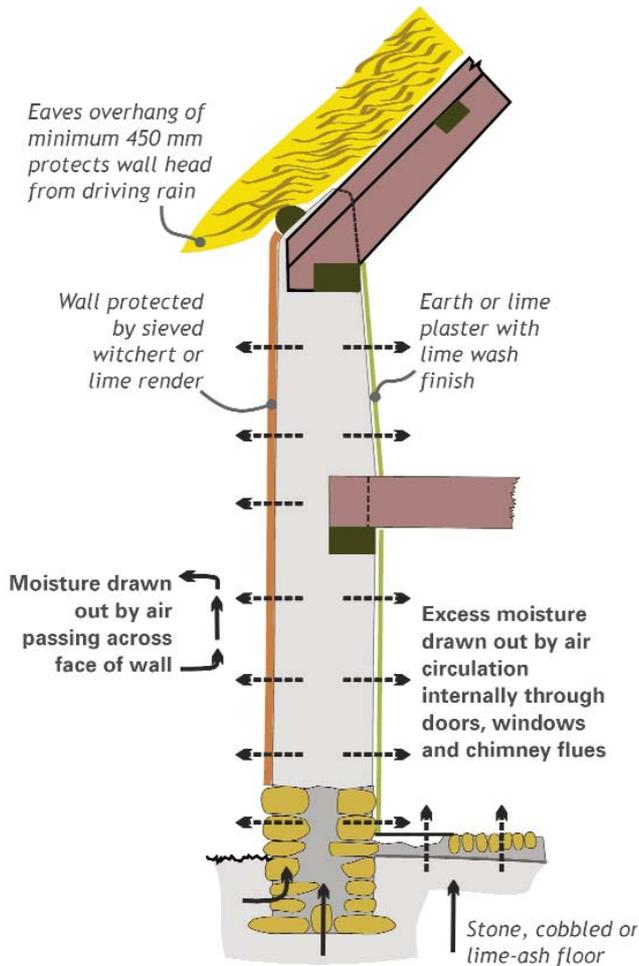
Figure 1A Wall of unaltered earth building showing how a state of moisture equilibrium is achieved

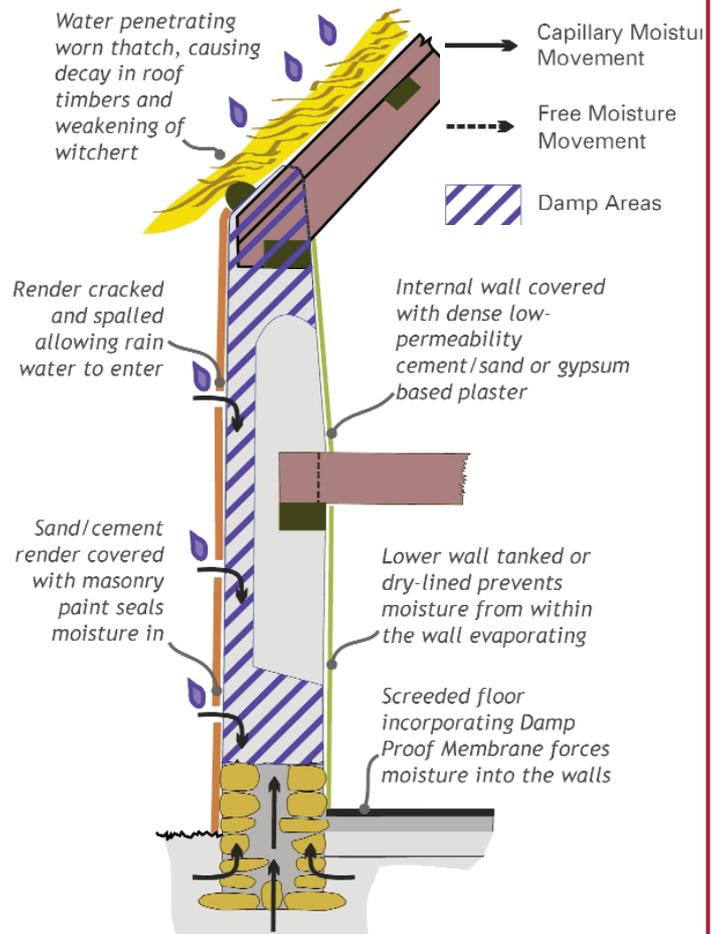
Figure 1B Neglect combined with inappropriate repair/maintenance can upset the balance by retaining moisture within the walls and lead to rapid deterioration

Cement-rich renders and dense plasters, coated in impervious paints, create strait-jackets, which stop buildings from breathing, trap moisture and prevent early detection of trouble caused by decay of the binding material. A prolonged, high moisture content can create conditions which will wash out the fines and may rot the straw. Moisture allows the build up of soluble salts, which in turn breaks down the materials, transforming the non-shrinkable clays into fine shrinkable clay. This

loose material in turn is washed down the narrow channels created within the wall by water. The results are pockets or layers, usually near the bottom of the wall, of friable witchert that has lost its strength and even drying out may not cure.

The sudden failure or removal of this strait-jacket can lead to collapse of an entire wall, the lower sections of which may have been substantially weakened over a long period.

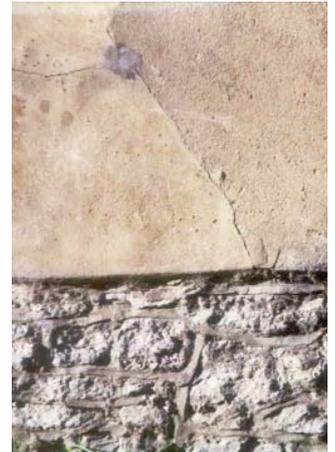
Cement mortar pointed grumplings and cement render. Cracks in both are drawing in water through capillary action. The moisture is unable to escape through dense render and cement mortar.

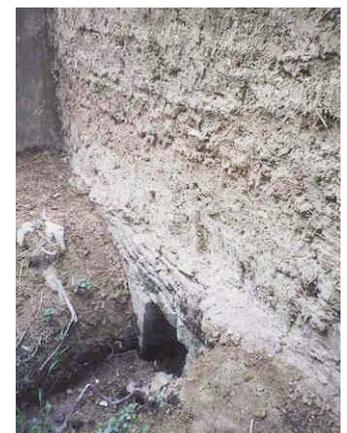
Newly rebuilt witchert wall over stream before trimming.

Repairs to witchert walls need to be carried out using earth materials. Sound witchert can be reconstituted or freshly dug from the ground and applied in berries when wet. Alternatively the material can be shaped into blocks, allowed to dry and used like bricks with a witchert slurry as mortar.

Because the use of dried witchert blocks avoids the problem of shrinkage this is one of the most straightforward repair methods. Small areas of hollows and depressions can be dubbed out with earth or lime mortar, having been cut back to sound material first. The new material must be allowed to set before a plaster or render is applied.

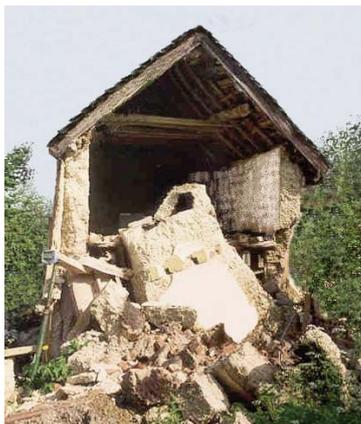
The photograph shows what happens when the solid ground on which the earth walls are founded, is dug away from below its foundations in order to underpin it. Witchert is a monolithic building material, which cannot cope with the stresses imposed by such massive intervention.

Neither of these should ever be introduced to a witchert building. If your mortgage company or adviser disagrees, show them a copy of this leaflet. A DPC on its own in the porous rubble stone of the grumplings will most certainly be totally ineffective and may also damage the stones. A DPC combined with cement mortar pointing and waterproof render and plaster will trap moisture and inevitably lead to decay of the witchert. A DPC put directly into the witchert may cause long term damage as free thermal movement, essential for the health of the wall, is impeded. This can result in the formation of cavities and moisture reservoirs, leading to major structural failure in the long term.
